# Final Report

## Microstructure and Epitaxy in Oxide Superconductor Thin Films and Devices

Grant # F49620-92-J-0159

Principal Investigator: Altaf H. Carim

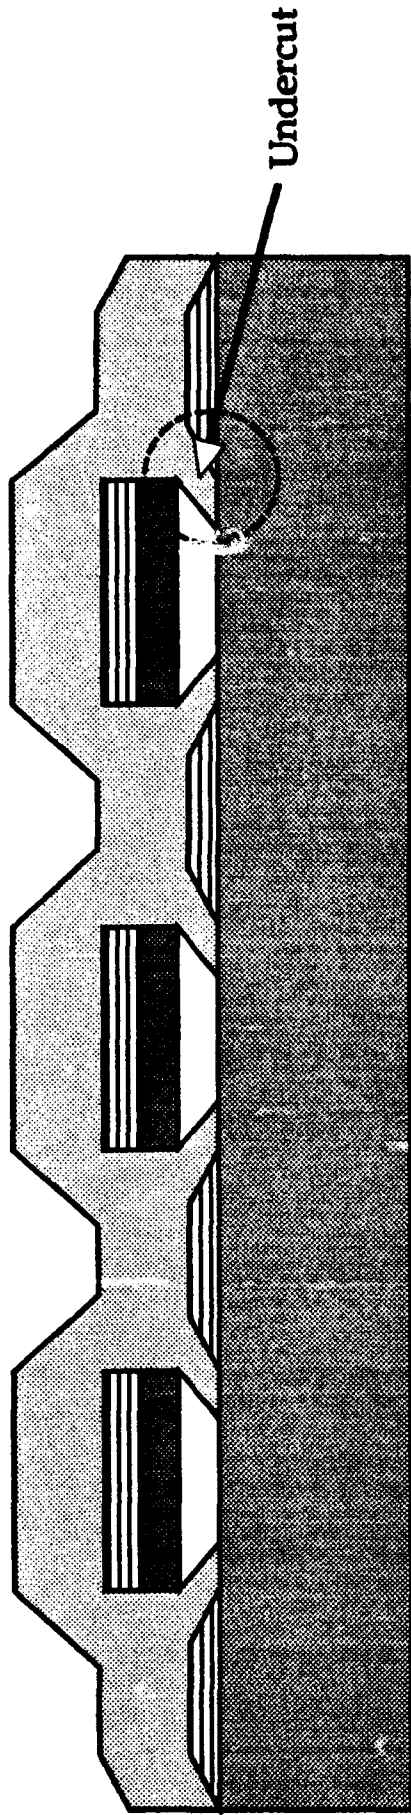
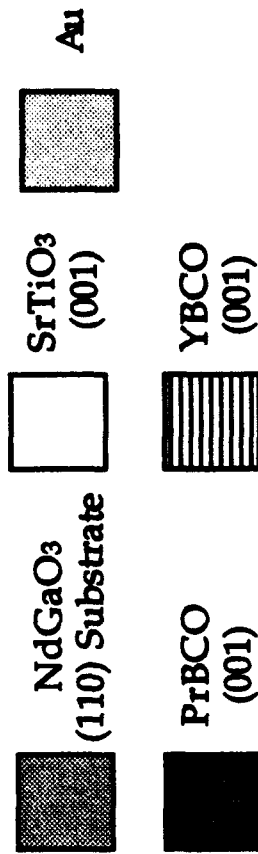
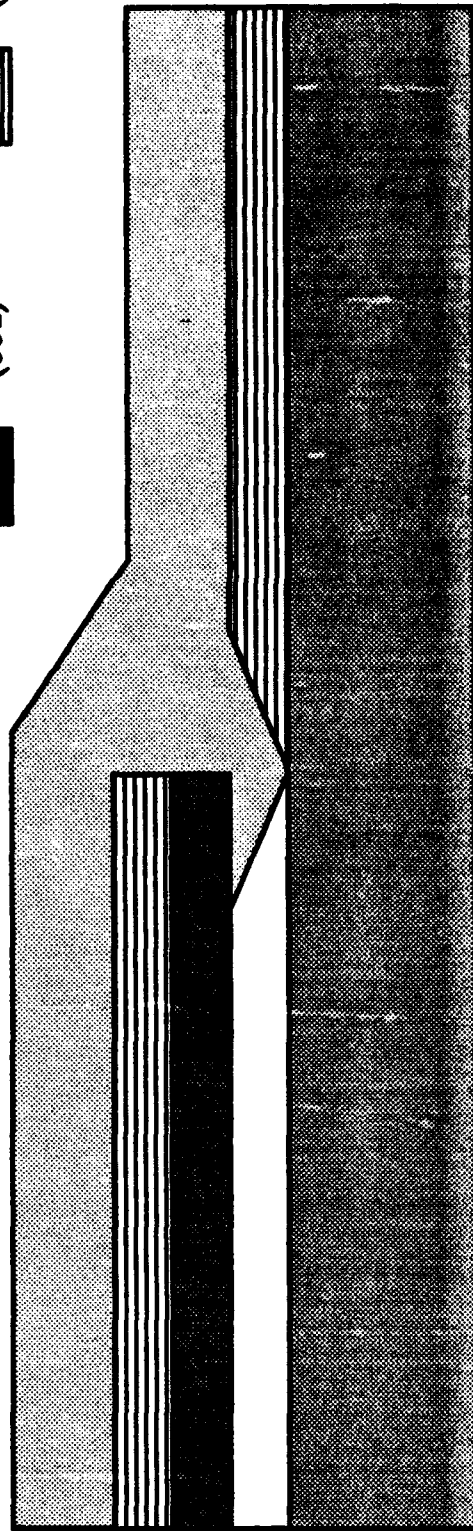
Figure 1: YBCO Step-Edge Junction Chip  
(Cross-Sectional Views)

**Figure 1: YBCO step-edge junction chip (cross-sectional view).**

YBCO Step-Edge Junction (Multiple Steps)

YBCO Single Step-Edge Junction (Cross-Sectional View)

Deposition of each successive YBCO,  $\text{SrTiO}_3$ , PrBCO and YBCO layer was done using a GC Magnetron followed by lithography and patterning using 150 eV argon ion etching techniques in order to achieve the final geometry (Figure 1).

The undercut proved to be successful in preventing short-circuiting of the device. As can be seen in Figure 6, the upper YBCO layer was not continuous in this sample. (For a corresponding schematic of the step-edge geometry, refer to Fig. 1.) Notice, however, that although the gold did deposit down into the undercut region, it failed to fill in the etched area completely. As a result, the gold layer was often discontinuous across the junction. This contributed to the poor electrical behavior of the chips.

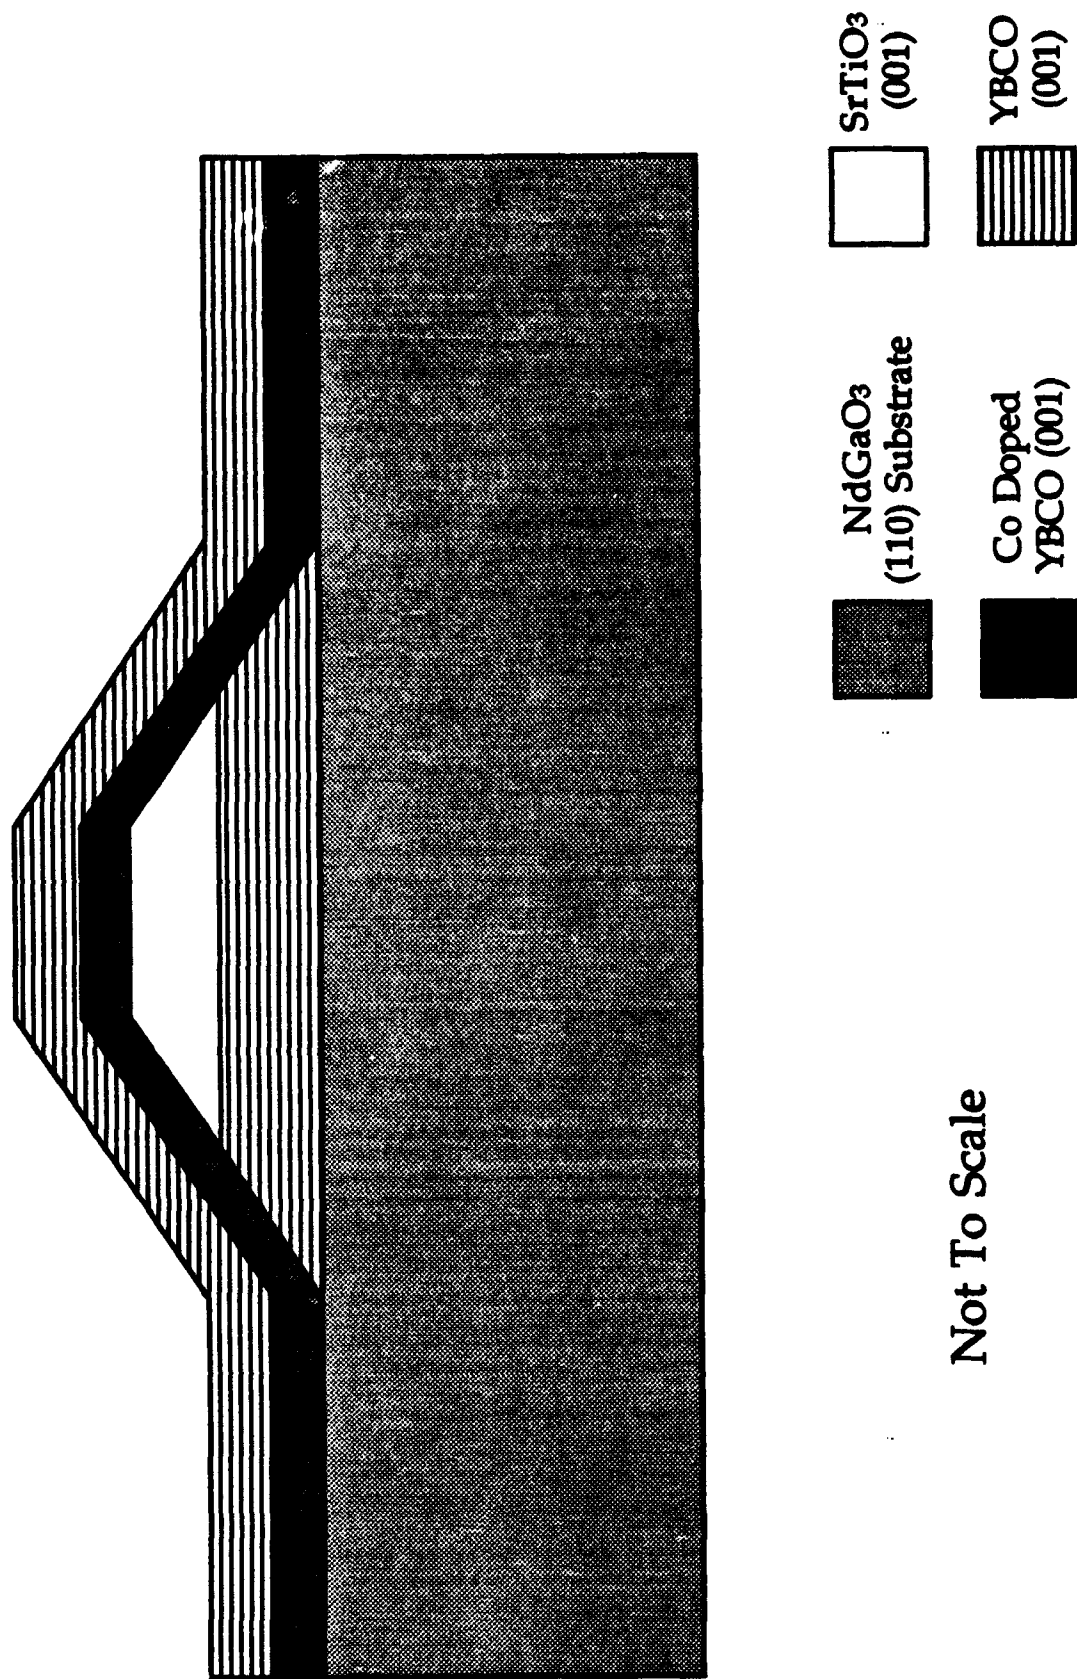
Figure 2: YBCO Edge Junction Chip with Co-Doped YBCO Barriers  
 (Cross-Sectional View)

**Figure 2: YBCO edge junction chip with Co-doped YBCO barriers (cross-sectional views).**

These devices were fabricated in much the same way as the prior set of step-edge junctions. Once again, the layers were deposited by 90° off-axis sputtering, and the deposition and patterning processes were conducted consecutively without breaking vacuum. The tunnel barrier in this case is a layer of Co-doped YBCO. The geometry of the device is somewhat different for the edge junctions versus the previously-discussed step-edge configuration, as illustrated in Figure 2. In this case, no undercut was required.

In order to make the best use of the available time, Dr. Talvacchio also sent another chip along for TEM preparation before T93-94-UTEST15 could be analyzed. This sample contained devices with the edge junction geometry described earlier and shown in Figure 2. A TEM sample

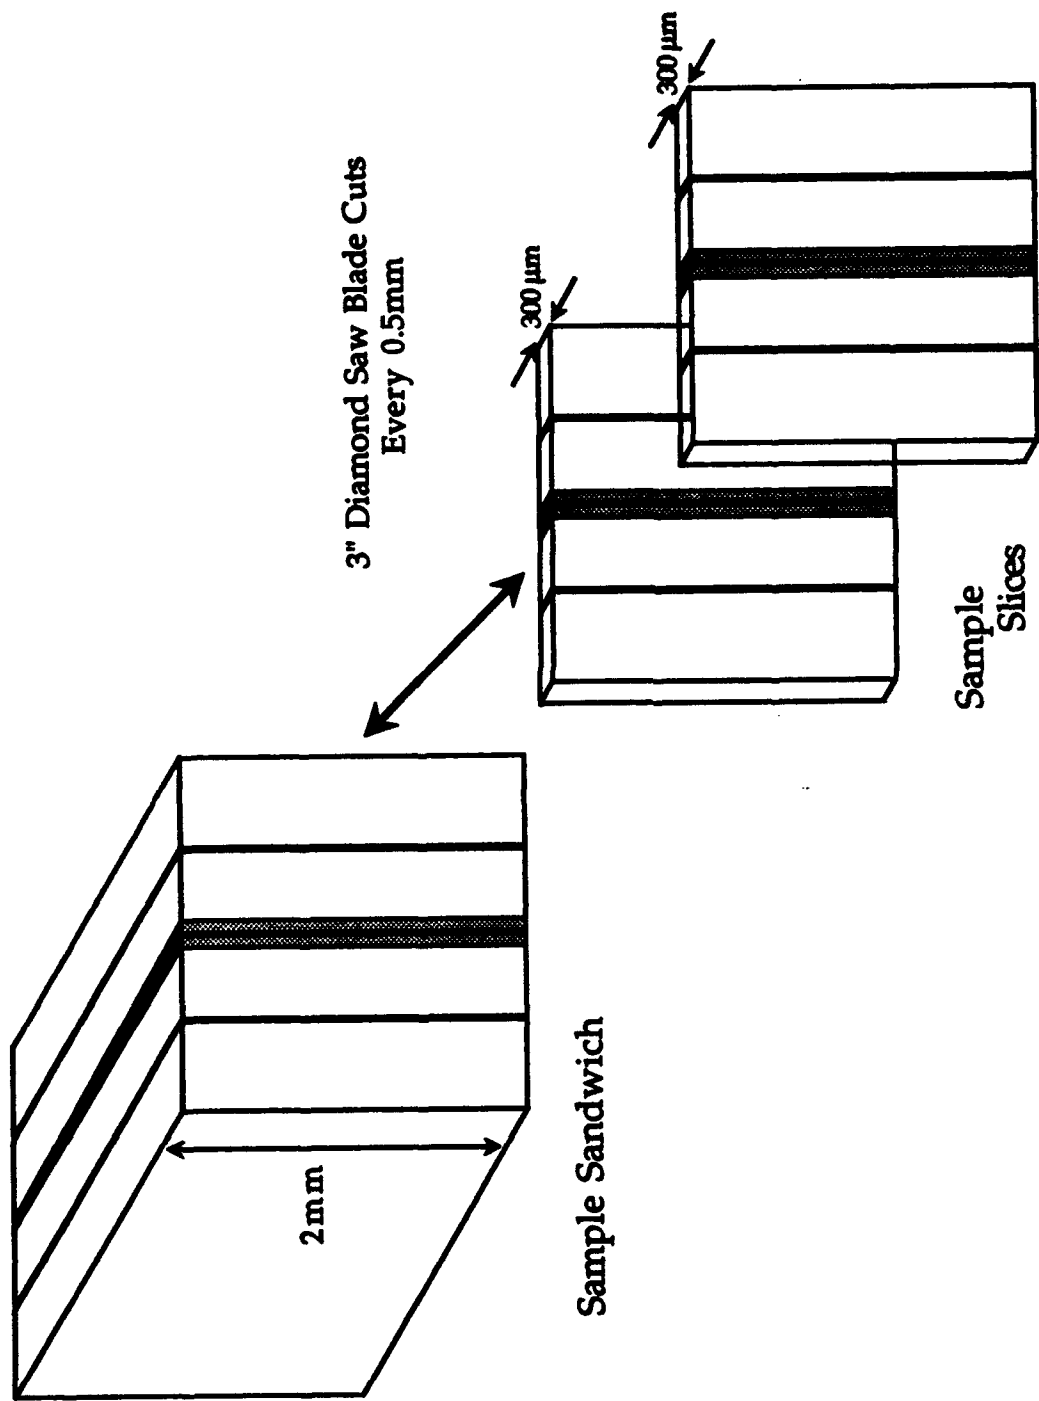
Figure 3: Cross-Sectional Sample 'Sandwich'

**Figure 3: Cross-sectional sample "sandwich".**

The TEM specimens were made from the chips as briefly described below. First, the chip was cut and bonded as illustrated in Figure 3 in order to make a 'sandwich'. An approximately 300  $\mu\text{m}$ -thick sample slice was then cut from the sandwich and thinned down to approximately 10-15  $\mu\text{m}$  using a Klepeis tripod polisher. Then the sample was ion milled in a Gatan ion mill at liquid nitrogen temperatures, using the sector speed control, at a low ion gun angle of 12° (see Figure 4) until perforation occurred. This method did require more time than some simpler approaches that were attempted, but it proved to be particularly successful when working with samples such as these which contain several diverse materials.

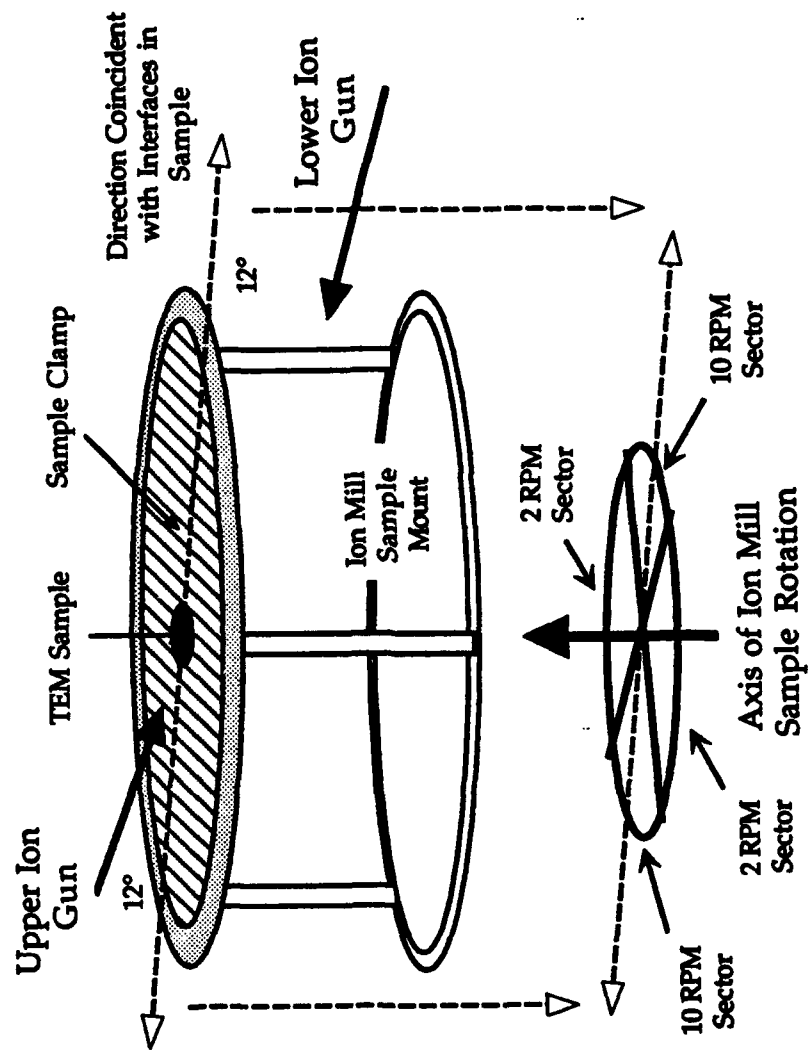
Figure 4: Schematic of Ion Mill Sample Holder and Milling Orientation

**Figure 4: Schematic of ion mill sample holder and its orientation.**

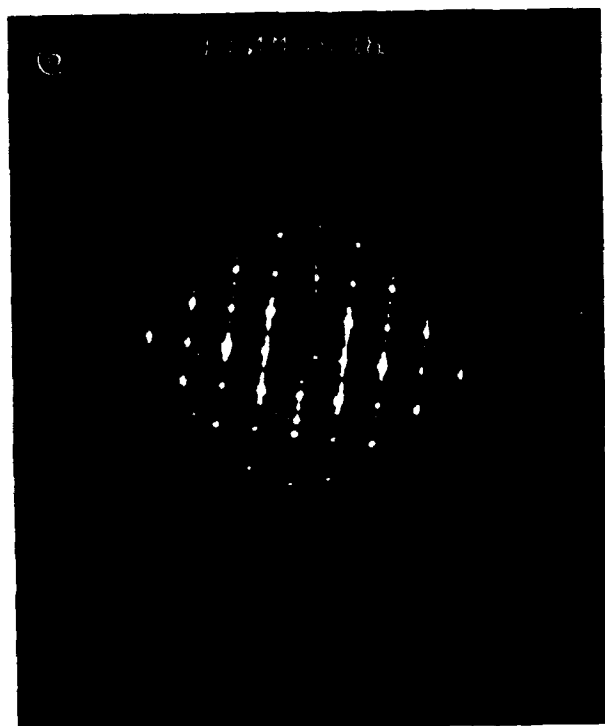
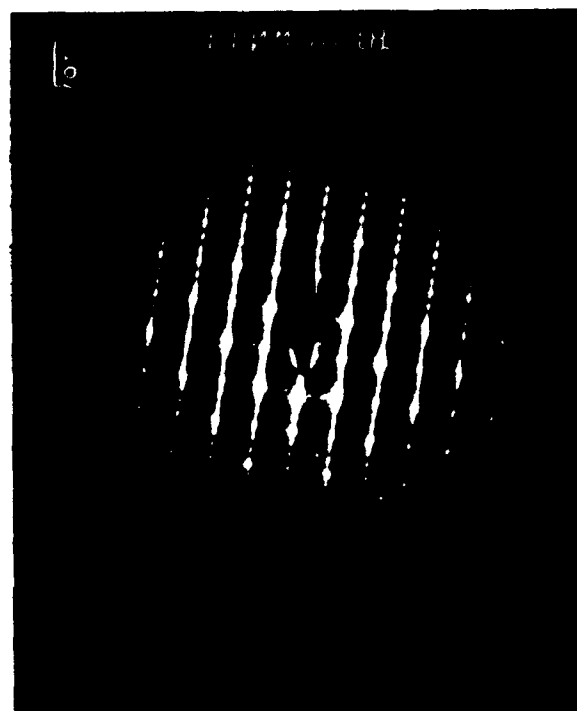
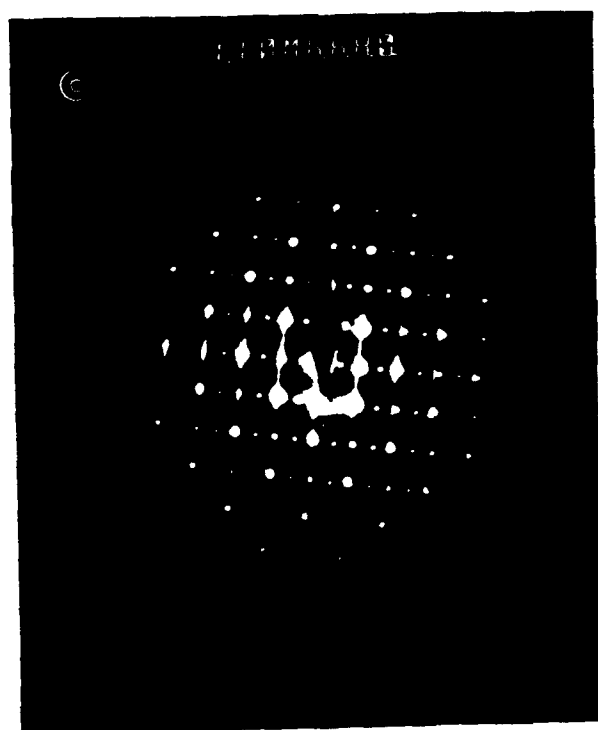
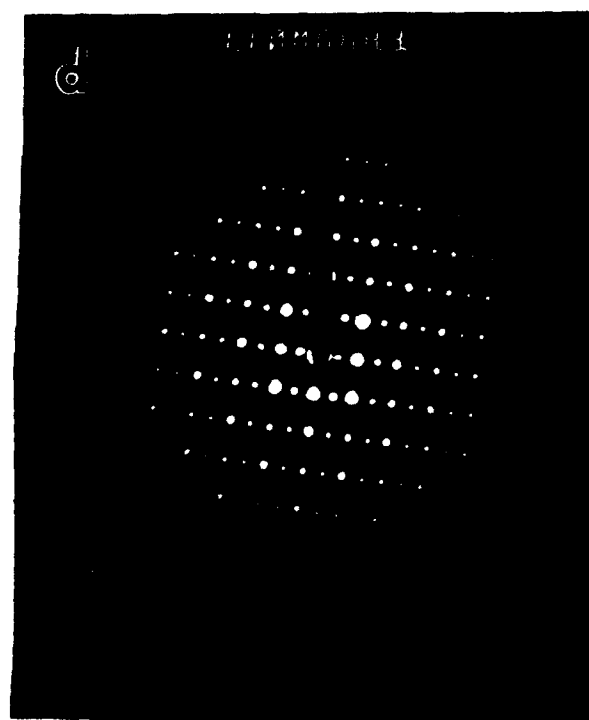
Figure 5

**Figure 5: Selected area diffraction patterns from adjoining areas in the (a) YBCO, (b) PrBCO, (c) SrTiO<sub>3</sub>, and (d) NdGaO<sub>3</sub>. The excellent epitaxy of the layers is evident.**

Diffraction analysis of the individual layers in this chip confirms that the expected and desired relative epitaxial orientations were obtained, as shown in Figure 5. These selected area diffraction patterns were obtained by translation across a thin region between two edges that extended across the layered "island" structure from the upper YBCO layer (Fig. 5a) through the intervening PrBCO (Fig. 5b) and SrTiO<sub>3</sub> (Fig. 5c) layers and finally into the NdGaO<sub>3</sub> substrate (Fig. 5d).

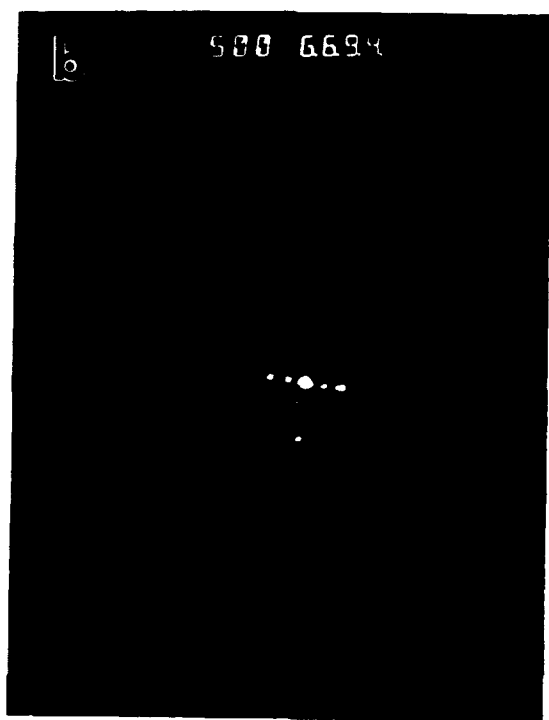
Figure 7

**Figure 7: (a) Bright field micrograph of a single step-edge junction with a misoriented edge grain in the PrBCO; (b) selected area diffraction pattern from the misoriented PrBCO grain; and (c) selected area diffraction pattern taken from an area including both the misoriented PrBCO edge grain and the epitaxial PrBCO.**

Another problem that is illustrated in Fig. 6 is the inconsistent formation of the YBCO/PrBCO edges. The four separate devices shown in these micrographs should all exhibit the same shape of the insulator/superconductor stack, but instead we see that in some cases a smooth, continuous edge is present whereas in others the YBCO layer is smaller in the lateral dimension(s) and that this can produce a notch at the edge of the island. Figure 7a illustrates another formation problem found in this chip: an edge grain in the PrBCO which is out of epitaxial orientation. Figure 7b is a selected area diffraction pattern taken from the misoriented edge grain and Figure 7c is a selected area diffraction pattern taken from a region including both the epitaxial PrBCO, which makes up the bulk of the layer, and the rogue grain at the edge. Note that, at least in this case, the subsequent YBCO layer nonetheless appears to be a continuous film without any interior grain boundaries.
